section
five

Commercial and Institutional Rehabilitation Guidelines

Commercial and Institutional Design Guidelines In Numerical Order

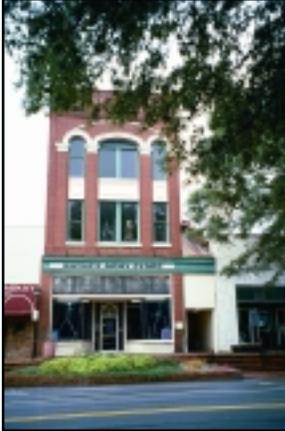
The elements and arrangement of the first-floor space identifies a building as a commercial enterprise open to the public. A storefront consists of specific elements such as large plate glass windows for merchandise display, transom windows that allow natural light into the store, and often a recessed entrance. The alteration, obstruction, or removal of these historic elements detracts from the historic commercial character of downtown Milledgeville.

This storefront retains its original transom, display windows, and recessed entrance.

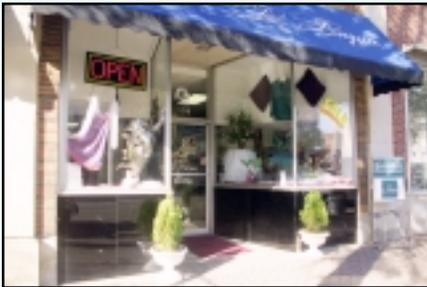
Some storefront additions and alterations that have been made over the years are of quality workmanship and illustrate the evolution of commercial design. Significant "modernized" storefront alterations such as Carrara glass panels or Art Deco styled glass block detailing are worthy of preservation.

This historic storefront alteration, above, illustrates the popular use of Carrara glass during the 1940s and 1950s and should be retained.

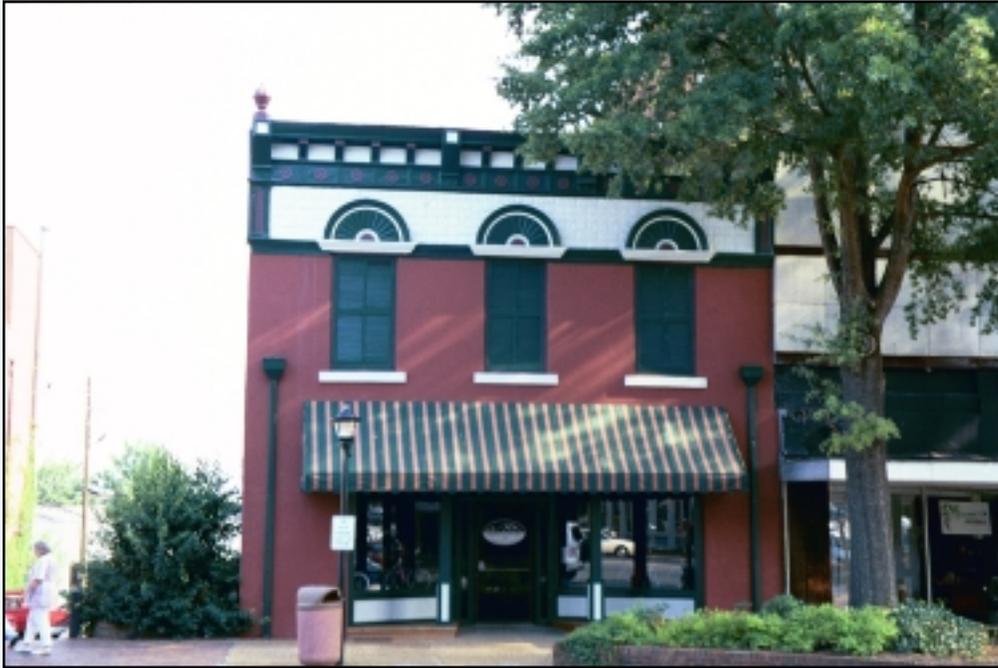
The removal of the nonhistoric aluminum cover has allowed for the reconstruction of this historic storefront

The removal of inappropriate, nonhistoric cladding and other later additions may reveal the historic character of the storefront. If a storefront is so deteriorated that repairing isn't feasible, physical evidence should be used as a model for reconstruction of that storefront. New storefront design should only be considered when there is not enough documentation to accurately reconstruct the historic storefront. Creating a false historical appearance is not an acceptable design solution.

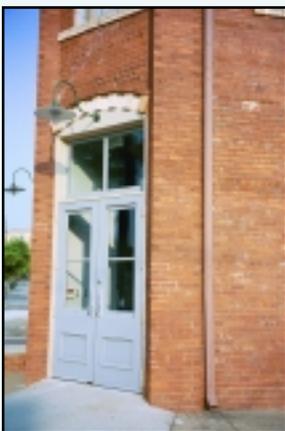
Besides storefronts, commercial and institutional buildings have other entrances that provide access to the establishment within. Some entrances may contain a stairway leading to a business or living space that is not on the street level. All entrances, including storefront entrances, should remain functional and retain historic features and details (doors, surrounds, transoms, and sidelights) whenever possible.

This historic corner entrance has been preserved.

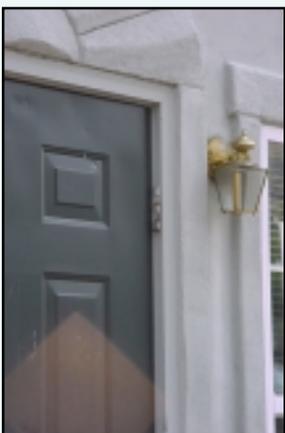
The location of entrances should not be changed unless based on sound documentation of a historic location. Modern or Victorian looking stock entrance doors, window units, and lighting fixtures or making a commercial entrance residential in appearance is an inappropriate design solution. Adding new entrances destroys the symmetry of the facade.

This lighting fixture and entrance door of this commercial entrance are residential in appearance and are inappropriate.

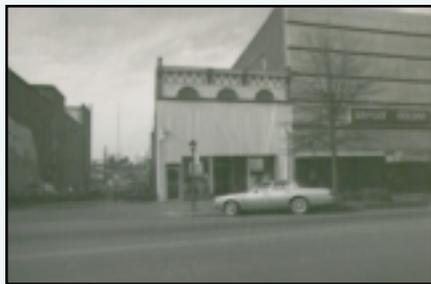
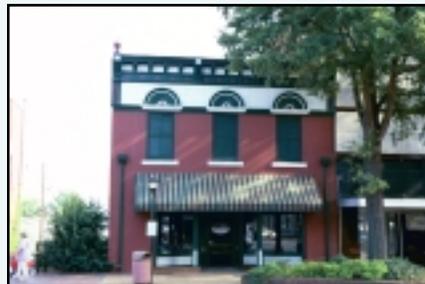
Removal of the aluminum facade facilitated the rehabilitation of this now contributing storefront.

The removal of nonhistoric metal cladding, false mansard roofs, or other upper floor alterations may reveal intact historic architectural details or window openings that could facilitate a facade restoration or rehabilitation. Removal of nonhistoric facades that obscure architectural details is encouraged.

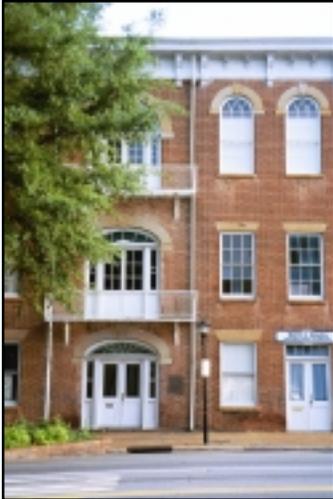
The upper facade on the Masonic Hall has been carefully preserved and maintained.

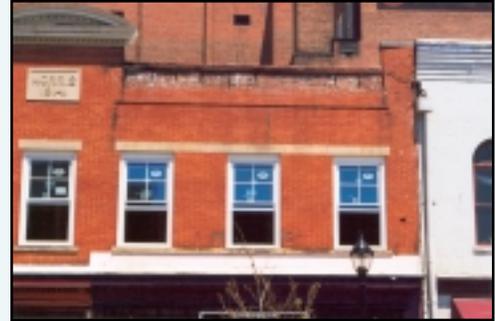
These new replacement windows do not match the known historic windowpane configuration.

5.3.5 Windowpane configurations and window size should match the original when replacement becomes necessary. Only true muntins and mullions should be used in replacement windows. Snap-in grid systems are not appropriate in the historic district. Vinyl-clad and aluminum-clad windows will be reviewed on a case-by-case basis.

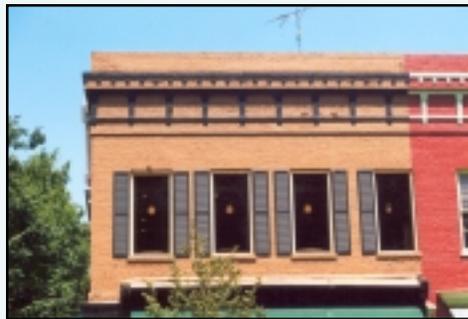
Upper floor windows on this building have been replaced with plate glass, removing all evidence of historic windowpane configuration.

The traditional proportion of windows to wall space on the upper stories of commercial buildings should be respected. Windows that have been filled-in give a commercial building a "blank" appearance just as the addition of new window openings disrupts the original rhythm of the building. Nonhistoric windowpane division can give a commercial building a more residential feel that detracts from the commercial character of the downtown.

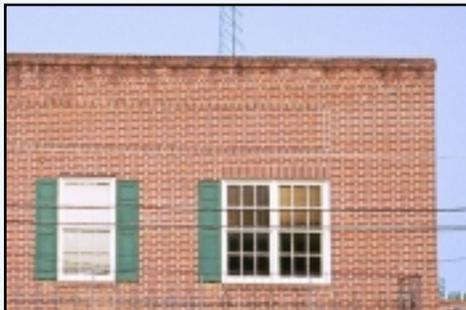
Nonhistoric shutters on this commercial building are inappropriately sized.

The inappropriate use of shutters that are hung improperly, non-operable, of incorrect size or attached to buildings with no historical documentation can significantly alter the look of a building. Shutters should be sized to properly fit the window and appropriate hardware should be used to install the shutters. Industrial buildings should have industrial shutters.

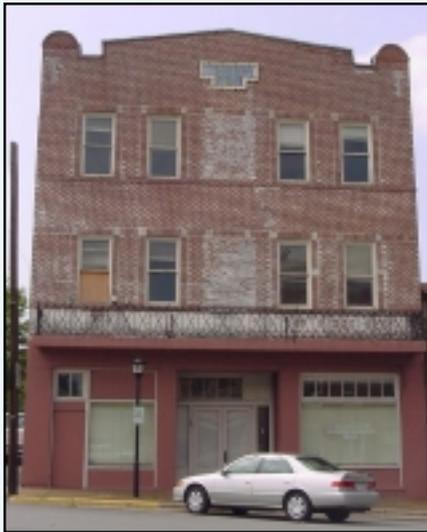
Restoring the doors in this historic front facade would enhance the symmetry, rhythm, and authenticity of this upper level space.

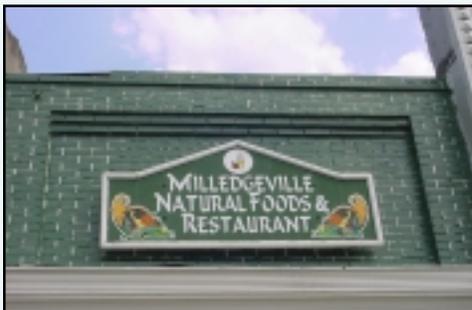
This wood sign is appropriately placed in the signboard area of the storefront where it does not obscure architectural details.

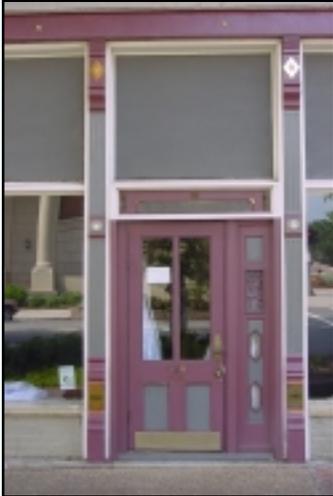
Architectural details are usually focused on a commercial building's primary facade. Significant details that should be retained include, but are not limited to, decorative window hoods and arches, pilasters, cornices, decorative brickwork, parapet walls, and other features that show the influence of design and architectural style.

Although some changes have been made to this entrance, the historic storefront columns have been retained.

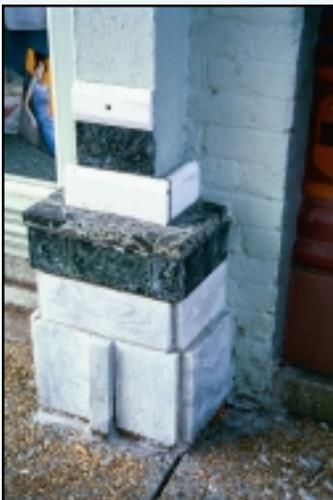
Marble has been improperly added to the base of this storefront column.

Applying details that are not grounded in historic documentation creates a false sense of history. The addition of certain types of details may provide an improper residential character for a commercial building. New materials such as fiberglass perform like traditional materials and may be a cost effective alternative to replacing damaged or missing architectural details.

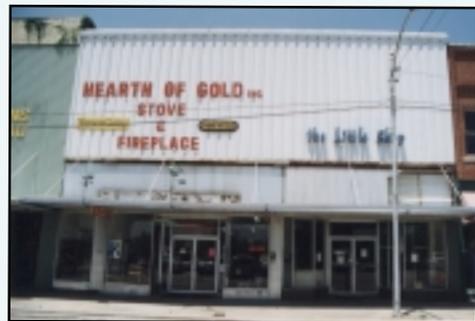
This upper facade and its storefront have been inappropriately covered with metal siding.

The use of nonhistoric siding materials (such as metal) is discouraged within the downtown commercial portion of the historic district. Replacement siding can alter and obscure original architectural details. Every effort should be made to retain historic architectural details and remove nonhistoric facade materials. See Appendix for Milledgeville's "Evaluation Guidelines for Review of Applications For Use Of Synthetic Vinyl/Aluminum Siding On Existing Structures In The Historic District".

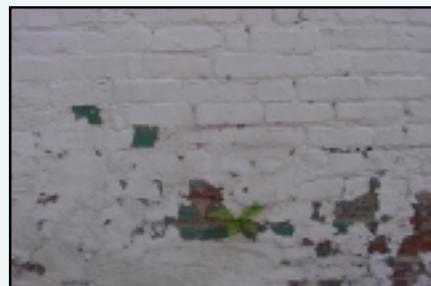
This historically painted brick surface should be regularly painted as part of routine maintenance for this building.

Unpainted masonry should remain unpainted, unless extremely damaged. When prepping any exterior surface, abrasive methods such as sandblasting and harsh chemical cleaners are not recommended as they can detrimentally alter the original material's protective surface. Harsh cleaning methods can deteriorate the protective exterior surface of brick exposing the softer inner brick to the weather. Repointing mortar joints should only be undertaken when necessary and appropriate techniques, tools, and materials should be used to avoid damage to the historic masonry and to match the existing visual character.

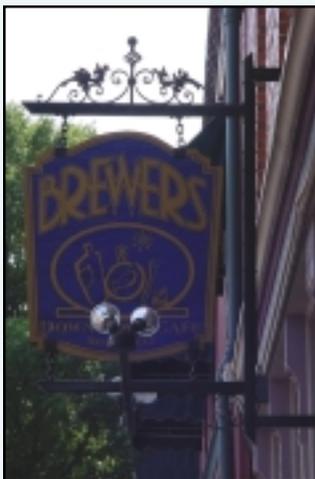
This is an appropriate example of signage in the historic district.

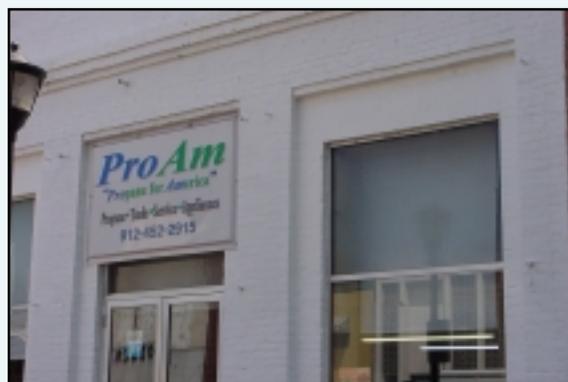
This signage has been placed in an inappropriate position on the building; obscuring the transom above the door.

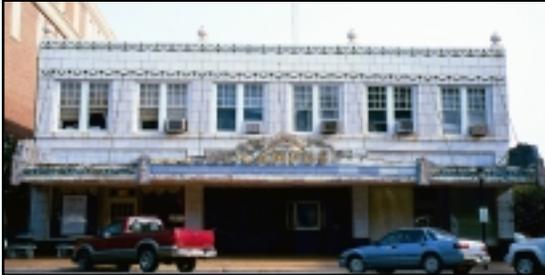
Awnings were historically used on commercial buildings to provide protection from the weather and sun for both the customer and the storefront. They continue to be popular today for providing visual enhancement.

This historic boxed awning is a significant component of this theatre and should be retained.

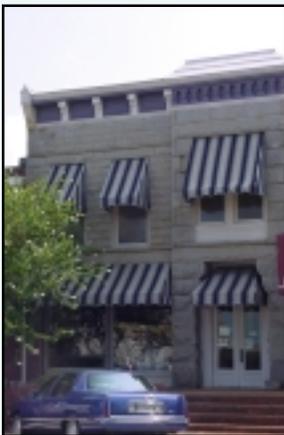
A commercial building with appropriately sized and placed awnings.

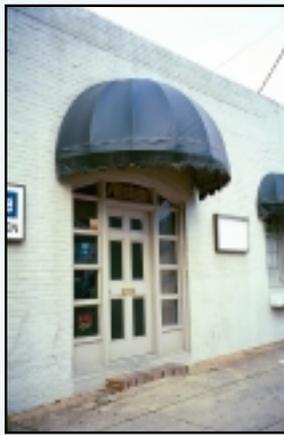
Round awnings should only be installed over arched or round window and door openings, such as the ones seen here.

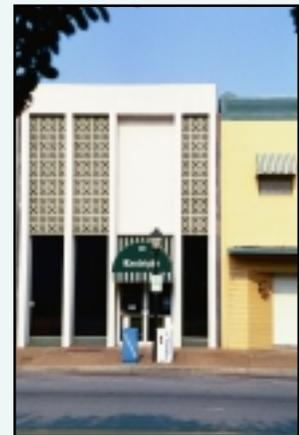
This round awning does not fit the square door opening.

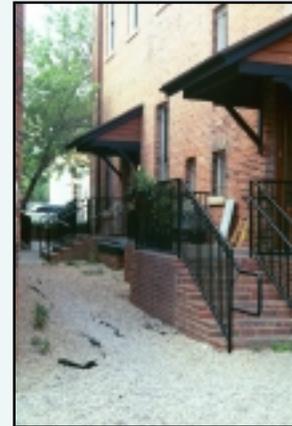
These rear entrances are well-designed and maintained, providing attractive secondary entrances for customers and employees in keeping with the historic building's style, details, and materials

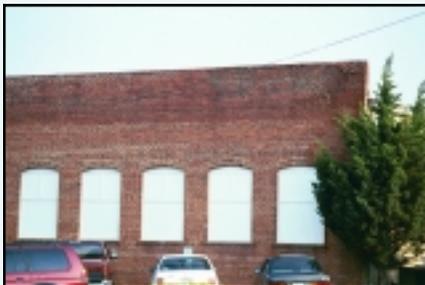
This visible side facade is maintained, but its windows have been covered.

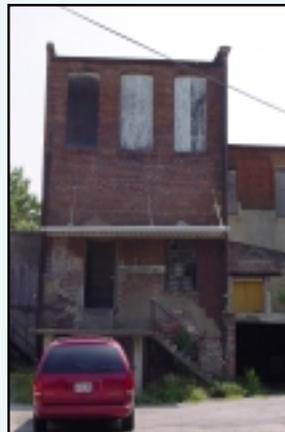
This rear loading dock is poorly maintained.

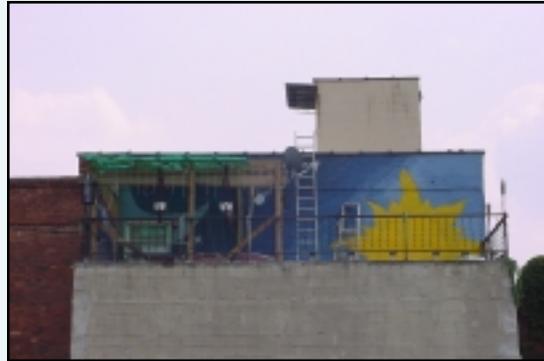
The covered area supported by pressure treated lumber is inappropriate in this rear balcony example, but is appropriate in size and scale to the historic building.

5.8.7 The use of unpainted pressure treated lumber or composite materials for decks and balconies is not appropriate to the character of the historic district.

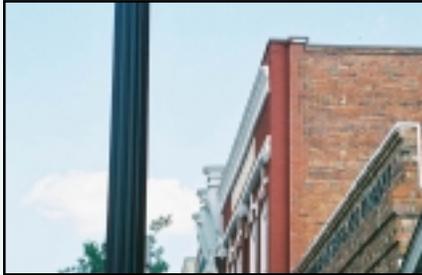
The majority of commercial buildings have flat or very slightly pitched roofs hidden by parapet walls. The introduction of other roof pitches in the downtown commercial district would not be considered appropriate.

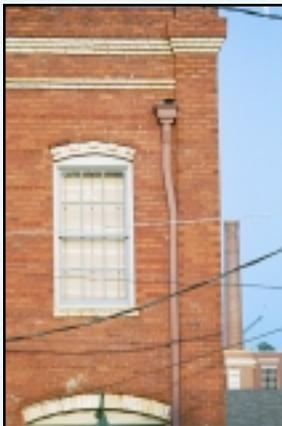
Adequate roof drainage is necessary to prevent water damage and deterioration of exterior building materials. Regular maintenance should be performed on gutters and downspouts. Gutters and downspouts should be placed in such a way that they do not obstruct window or door openings or architectural details.

This gutter and downspout system is in good condition.

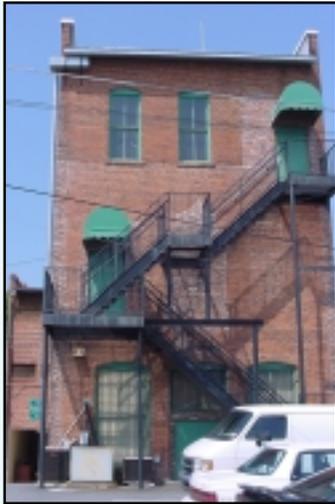
Modern mechanical systems for heating and air conditioning can easily detract from the historic character of the downtown when conspicuously placed. When placed at ground level, the system should be landscaped or fenced to shield it from being visible from the public right-of-way. When located on the roof, systems should be located far enough back from the main facades so that they are not visible from the street.

Mechanical systems that are tucked underneath rear stairs allow for easy accessibility and are generally less obtrusive.

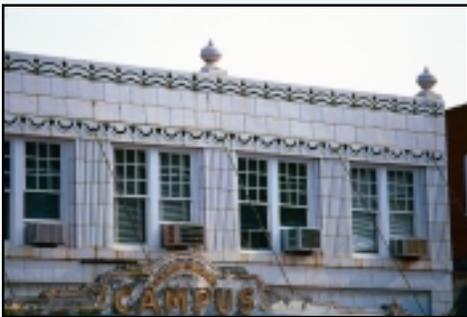
In instances where window air conditioning units are used, they should be placed in windows on less visible facades so as not to detract from the overall historic character of the district. Wall units designed to be mounted into holes cut into the side of an exterior wall are not appropriate, as installation would require destroying historic masonry.

Window air conditioning units on the front facades of historic commercial buildings are strongly discouraged.

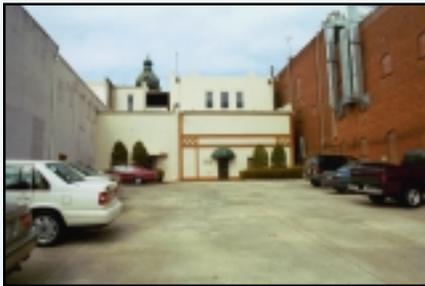
New additions to historic commercial buildings are generally made to the rear of the building due to the nature of the downtown district. Under no circumstances should the new addition be of greater height than the existing building.

The modern addition to the rear of this historic building does not overwhelm the existing building.

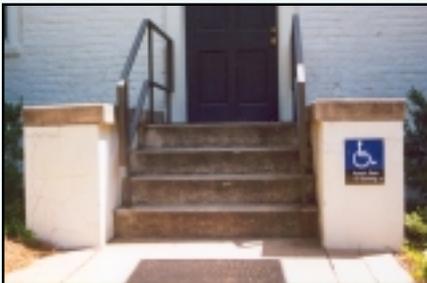
Signage directing disabled persons to a less visible entrance is a suitable design solution.

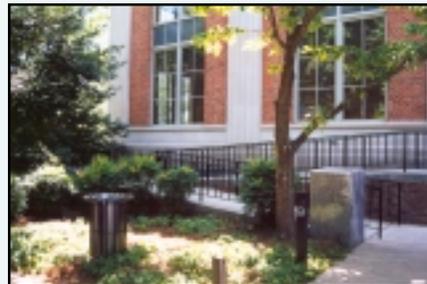
The impact of the ramp on this institutional building is softened by landscaping.

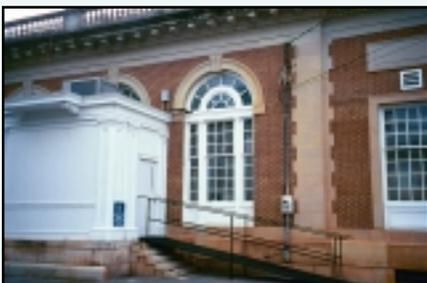
This handicap access ramp located on the rear of the building was installed in a manner so that its removal would not damage the historic masonry.

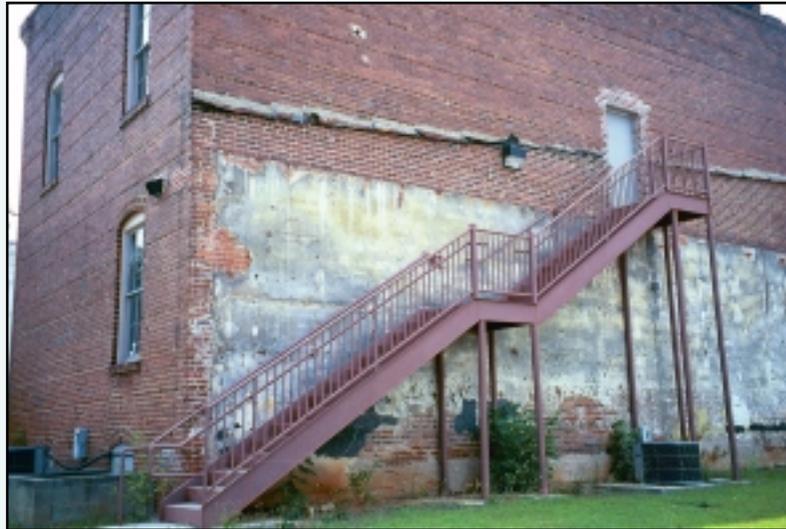
A simple, yet effective solution for a rear fire exit.

Necessary additional fire exits should be placed on the rear or side facades of the building and match historic door openings in scale and detail.

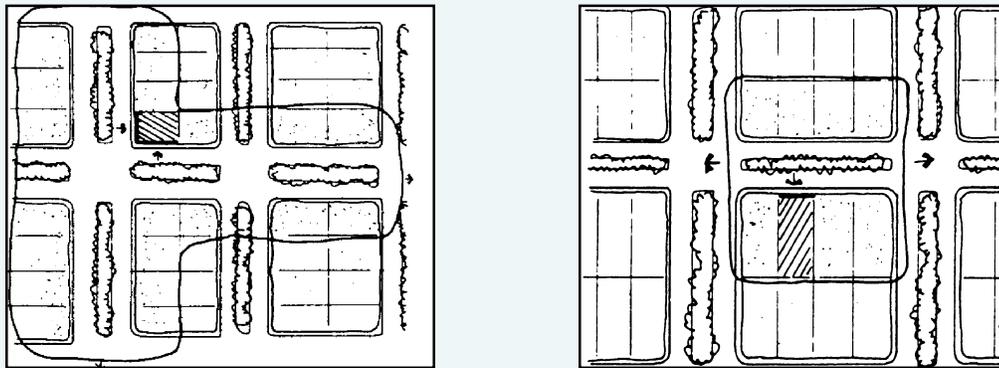
Area of influence: Each site within a historic district will have its own unique area of influence. Shown here are two different examples with suggested minimum areas that might be considered. Neighboring buildings should be examined to determine the consistent patterns of design concepts and architectural elements that are present.

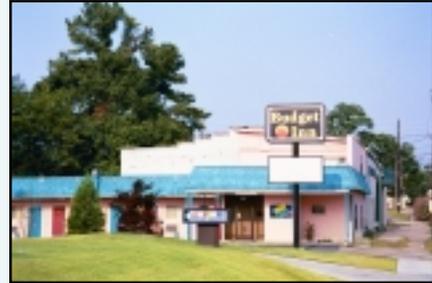
This modern hotel does not conform to the rhythm established in the historic commercial district.

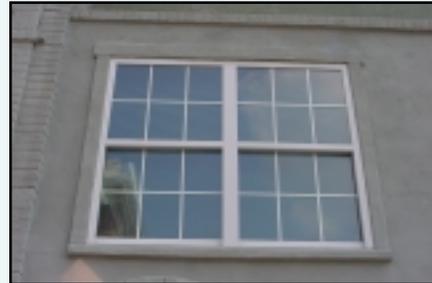
The snap in grid used in this window does not have the distinctive character that the historic windows for this building would have had.

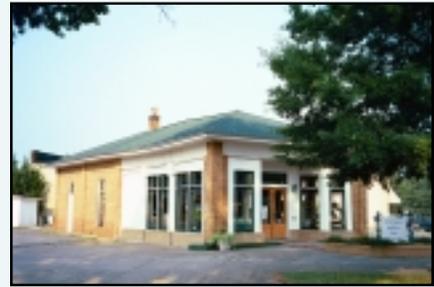
This former transportation resource has been sensitively adapted for commercial use.
