## section *six*

# Residential Design Guidelines

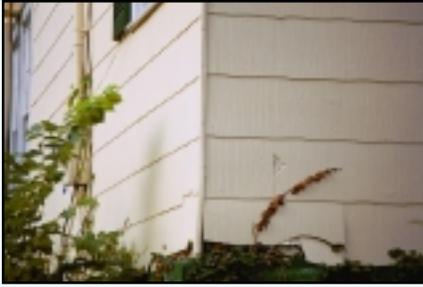
This asbestos siding is damaged and should be repaired or removed to uncover the historic wood siding.

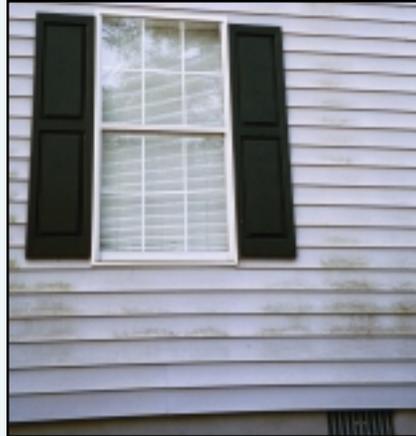
The use of vinyl siding on this house has resulted in a loss of significant architectural details. In addition, the mold growing on the siding is indicative of a lingering maintenance issue.

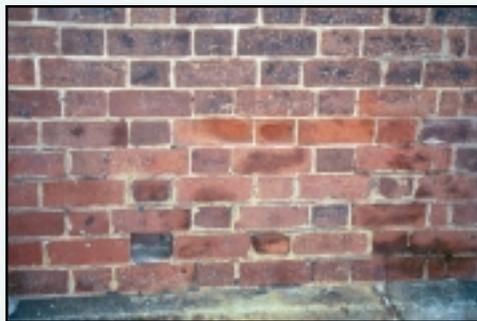
This brick has not been properly maintained allowing the soft inner brick to be exposed and deteriorate.

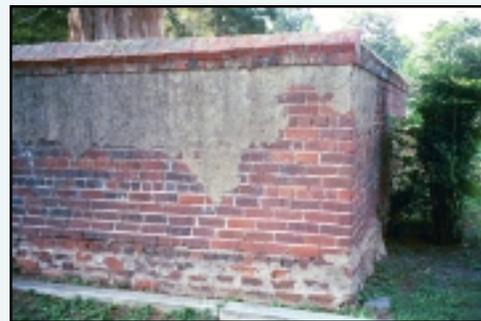
Repointing with Portland cement at the base of this wall has extended beyond the original mortar joints. Covering over the top portion of the wall can trap moisture and cause further brick deterioration.

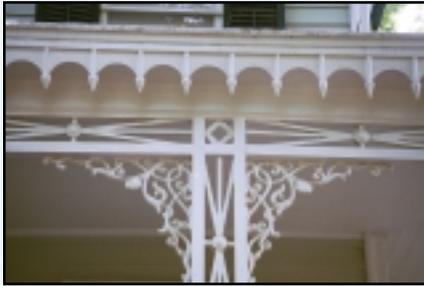
This porch scrollwork is an important architectural detail on this Victorian-era house.

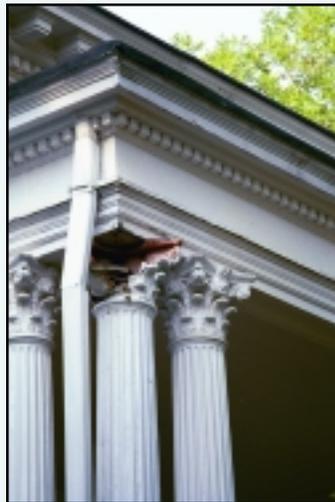
Columns, such as these, are an important character defining feature of the residential district. Enough of this column capital remains so that it could be repaired rather than replaced.

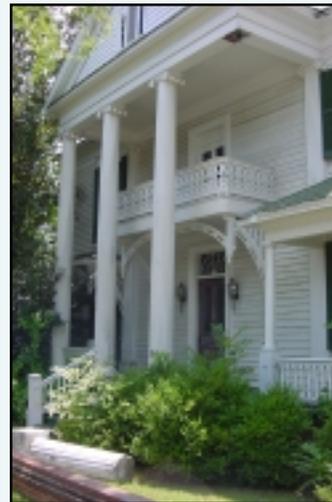
This concrete column has deteriorated beyond repair. Existing columns should be used to replicate the missing architectural detail.

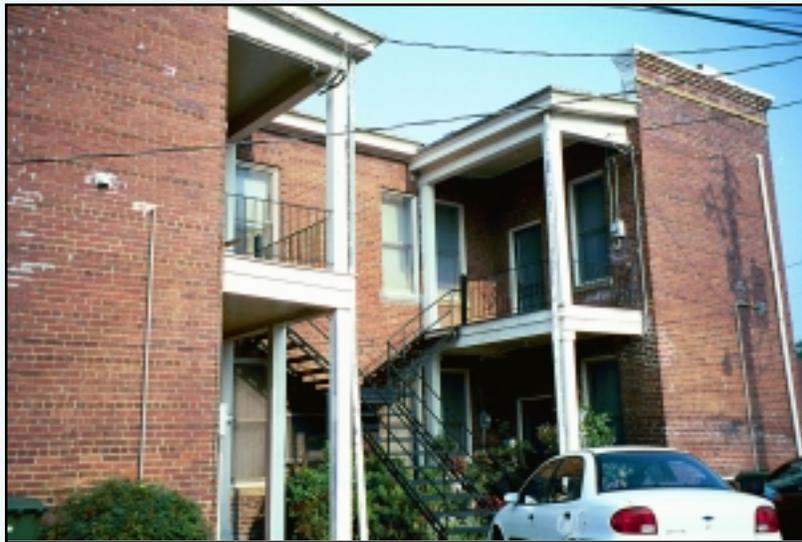
This larger home was successfully divided into multi-unit apartments. Needed balconies were added to the rear of the resource so as not to create a false sense of development.

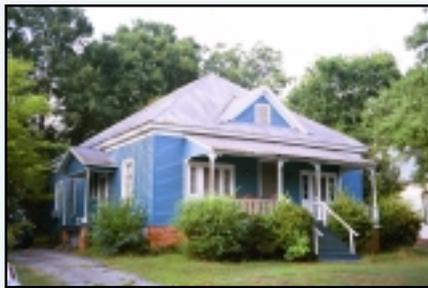
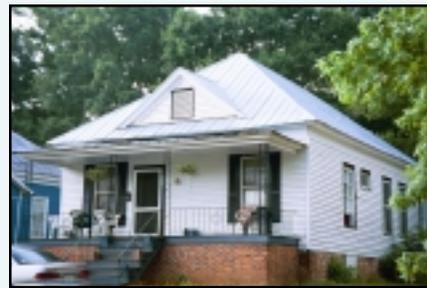
The cottage on the left retains its simple scrollwork on the porch posts while the cottage on the right has lost all porch detailing with the addition of nonhistoric metal porch posts and balustrade.

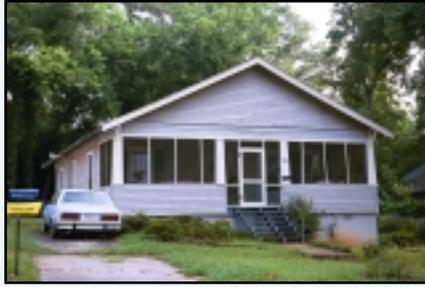
This porch has been screened in a manner that retains the original porch posts.

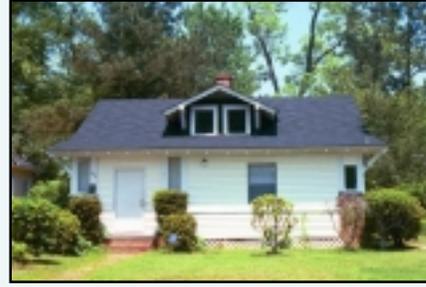
This front porch has been completely enclosed and the result destroys the house's historic integrity.

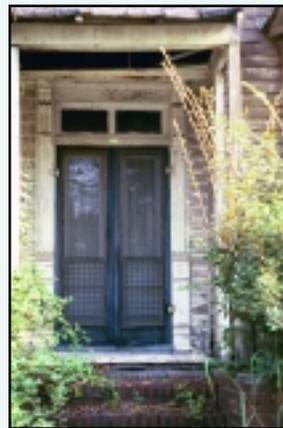
The wood screen doors shown here complement, rather than detract from, the historic character of the entrance.

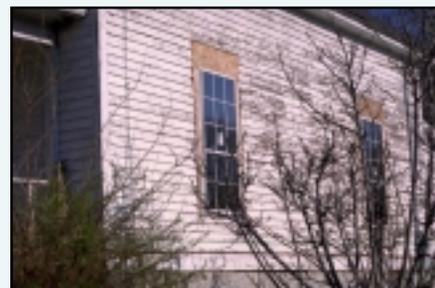
These new windows required alteration of the original openings and do not duplicate the historic windowpane configuration.

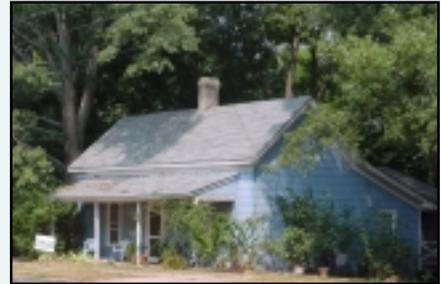
The chimney of this resource is a prominent feature and should be retained.

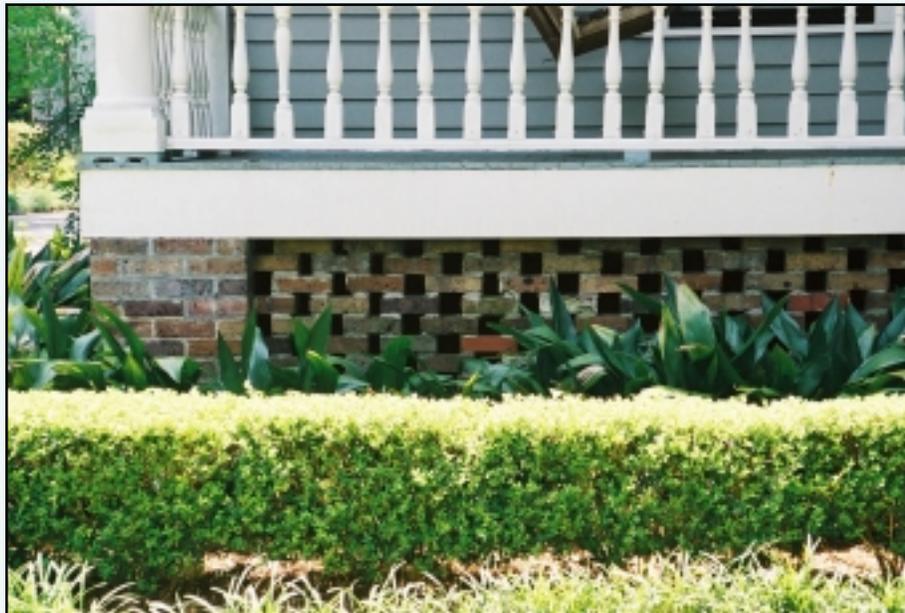
The brick infill between the piers of this foundation has been done in a lattice-like pattern which is somewhat in keeping with the historically open character of this foundation.

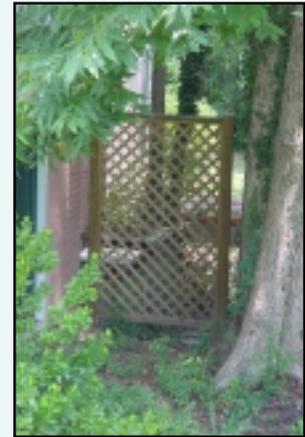
This mechanical system has been properly obscured with landscaping and latticework.

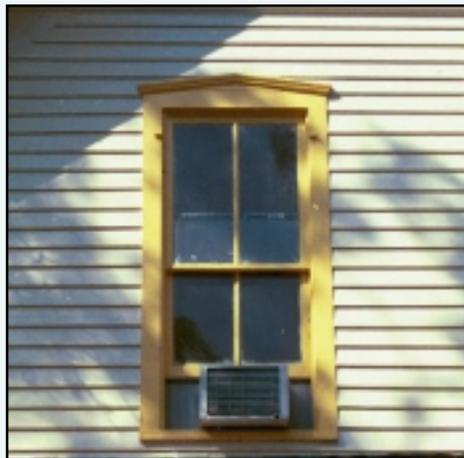
Window air conditioners should not be placed on the front facade of a historic house.

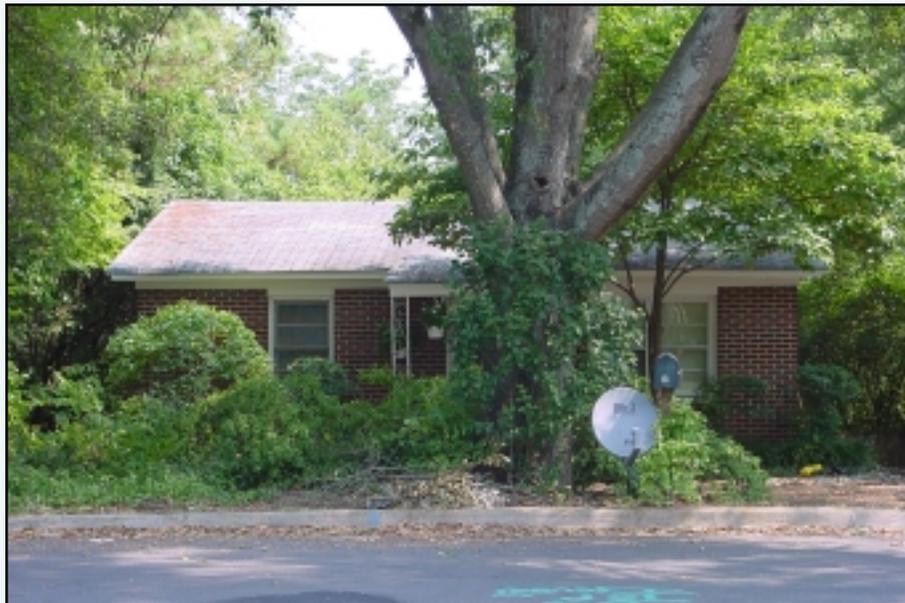
This satellite dish is inappropriately placed in front of this home.

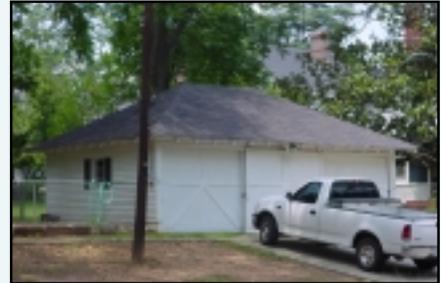
This historic garage has been properly maintained.

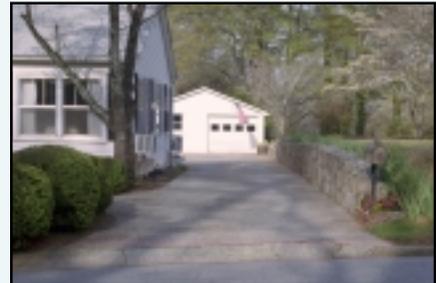
This modern garage is in keeping with the style and scale of the main house.

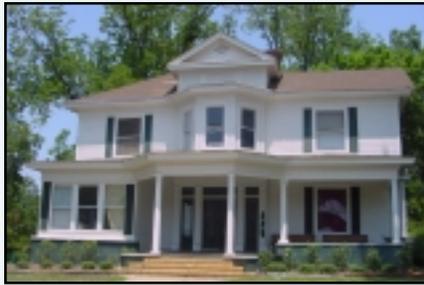
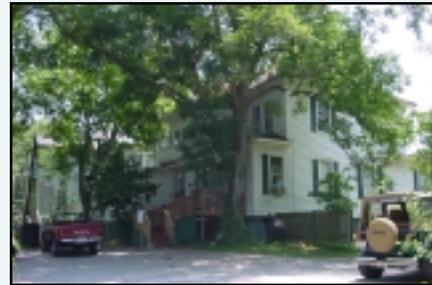
This historic house has been appropriately rehabilitated into an apartment building.

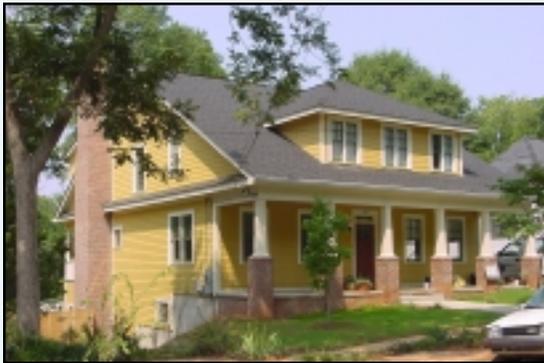
This modern home was designed to be compatible with the surrounding historic resources by borrowing such Craftsman elements as battered porch supports and widowpane configuration.

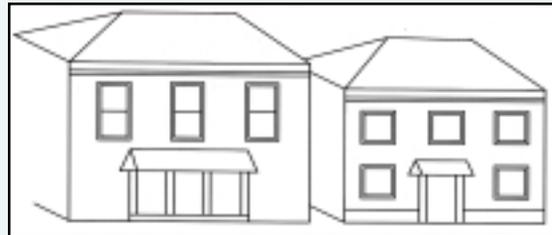
This depiction shows a newly constructed (right) home that utilizes the same roof pitch as its historic neighbor.

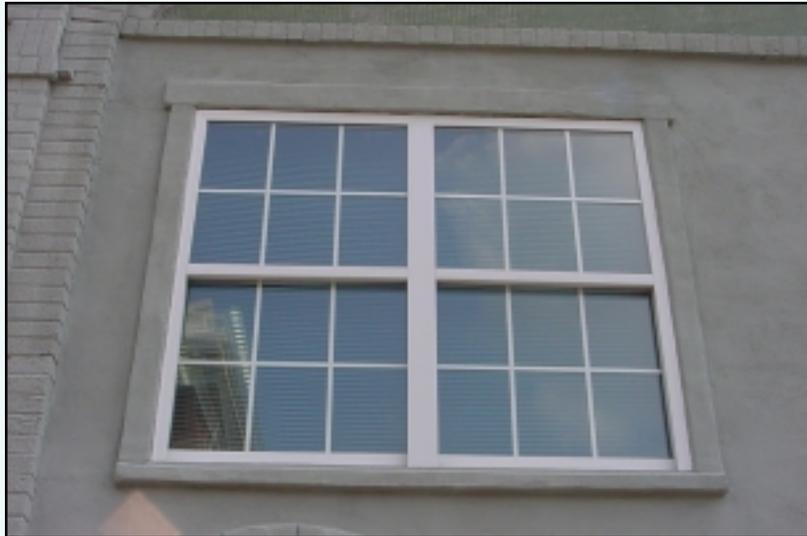
This is an example of a snap-in grid system for modern windows that is not appropriate.
